HOME INSPECTION

1234 Main st.
McAlester, OK 74501

Buyer Name
08/09/2022 9:00AM

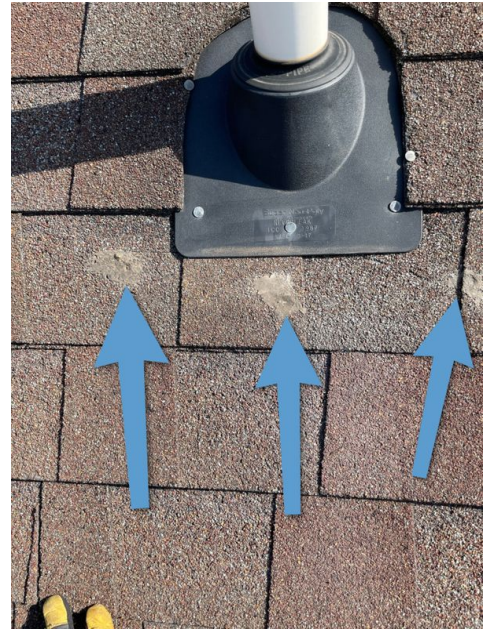
2.1.2 Roof Covering

ROOFING CEMENT PATCHES

Just an FYI, patching usually suggests a homeowner who has found leaks and is trying to buy a few more years by patching obvious cracks and nail pops.

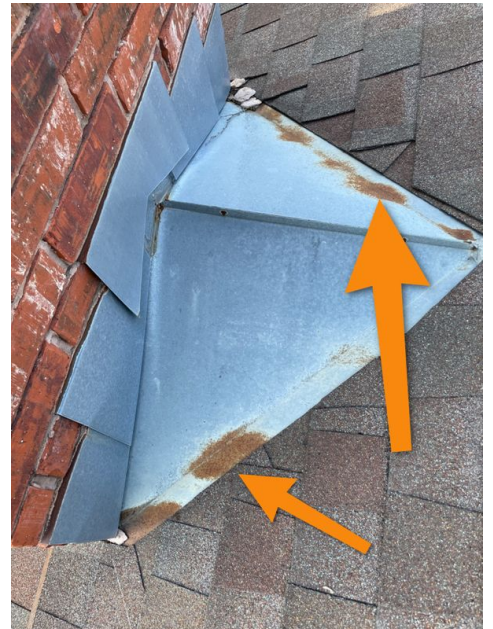
2.2.1 Flashing

CORRODED - MINOR

Roof flashing showed signs of corrosion, but seemed to not be a major defect. Flashing should be monitored to prevent severe corrosion leading to moisture intrusion.

Contact a qualified roofing professional.

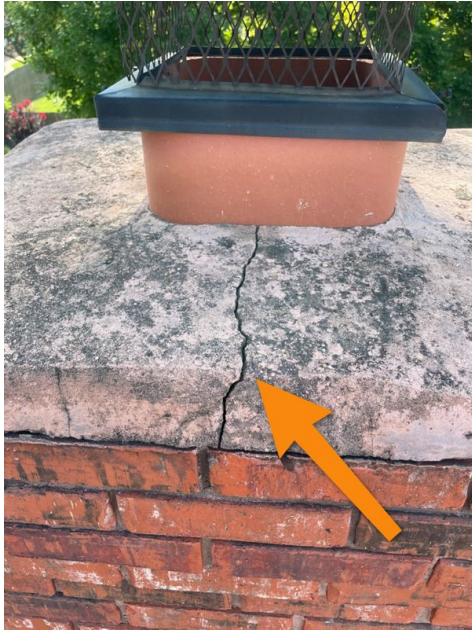
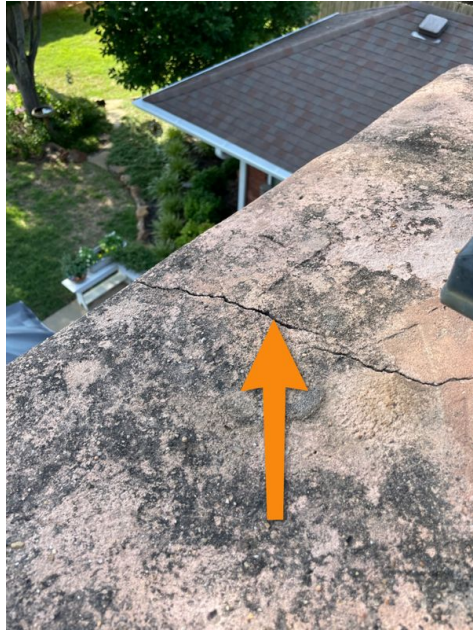
CROWNED CAP WAS DAMAGED

I observed indications of damage at the chimney wash or crowned cap. This is the top of the chimney that is shaped or "crowned" to divert water away from the top of the chimney stack.

If a wash or crown on top of the chimney is not properly sloped or is extensively cracked, defective, spalled, or displays rust stains, it should be replaced. Sheet metal caps/crowns with minor rust or corrosion should be repaired, but if rust or corrosion is extensive, replacement is recommended.

Contact a qualified chimney contractor.

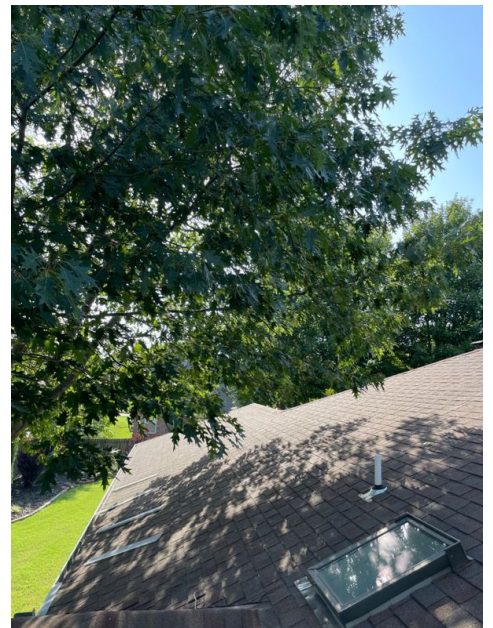
Trees observed overhanging the roof. This can cause damage to the roof and prevent proper drainage. Recommend a qualified tree service trim the limbs back.

Contact a qualified tree service company.

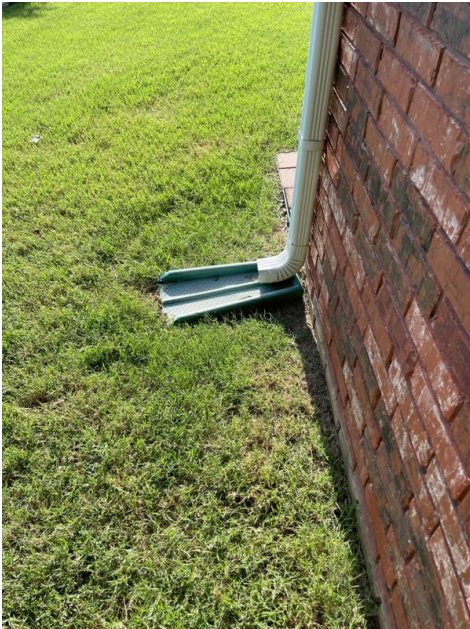
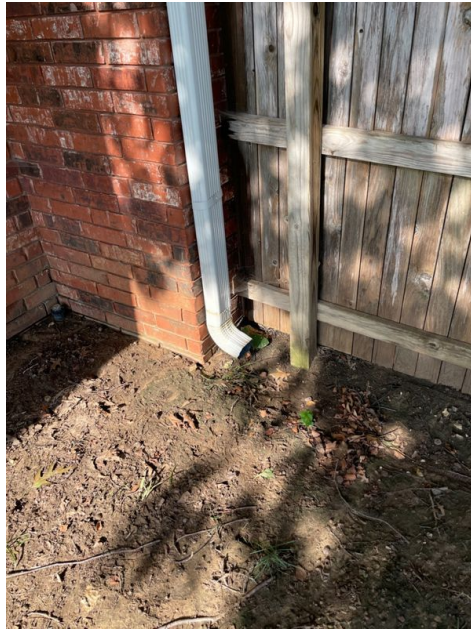
4.5.1 Gutters & Downspouts

DOWNSPOUT DRAINS NEAR HOUSE

One or more downspouts drain too close to the home's foundation. This can result in excessive moisture in the soil at the foundation, which can lead to foundation/structural movement. Recommend a qualified contractor adjust downspout extensions to drain at least 6 feet from the foundation. A handy homeowner should be able to do this project.

Recommended DIY Project

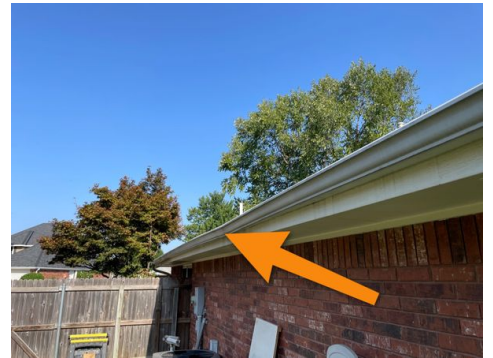
4.5.2 Gutters & Downspouts

GUTTER DAMAGED

I observed damage to the gutter. This is a defect that should be corrected by a professional contractor.

Contact a qualified gutter contractor

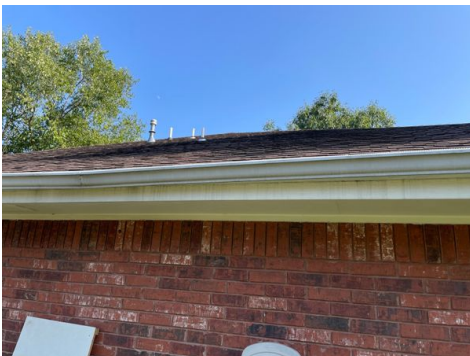
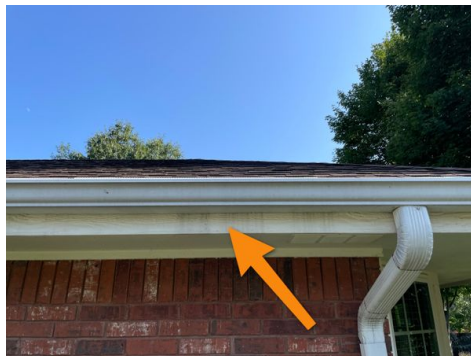
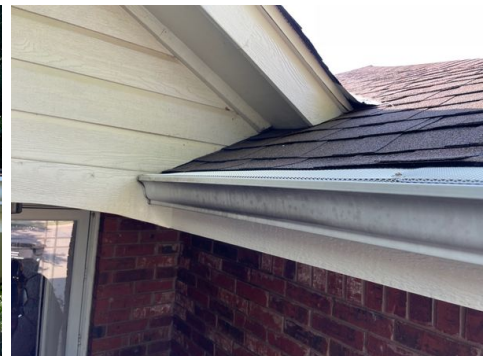
4.5.3 Gutters & Downspouts

GUTTER LEAKAGE

I observed evidence of a water leak from a gutter, which could result in water not being properly collected and drained away. This is a defect that should be corrected by a professional contractor.

Contact a qualified gutter contractor

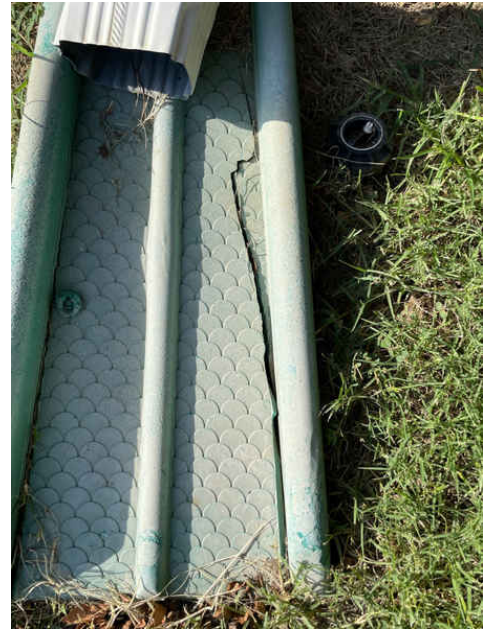
4.5.4 Gutters & Downspouts

DIVERTER BROKEN OR CRACKED

Diverted is cracked or broken, this can allow water too close to the foundation.

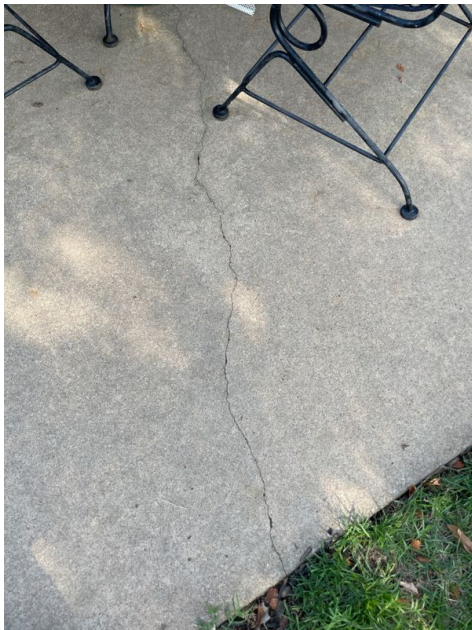
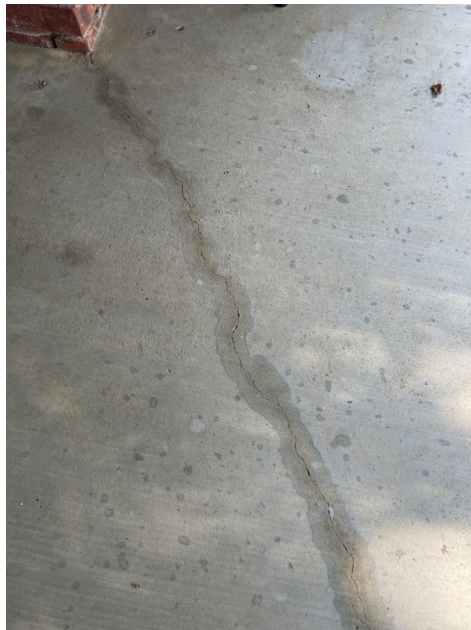
4.6.1 Decks, Patios & Balconies

PATIO CRACKING - MINOR

Normal settling & cracking observed. Recommend monitor and/or patch/seal.

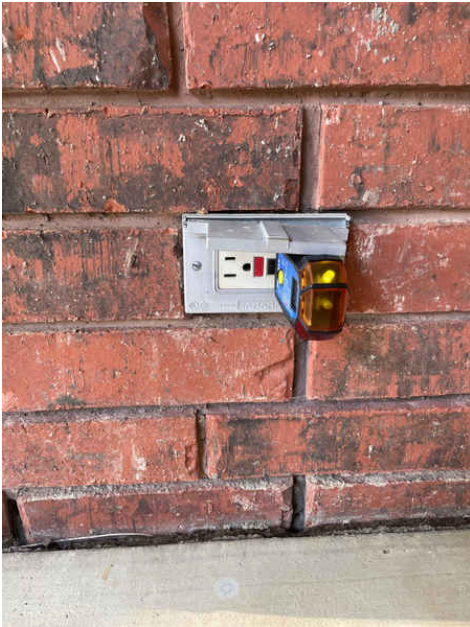
4.7.1 Electrical

GFCI DEFECT

I observed indications of a defect at a GFCI. Would not trip.

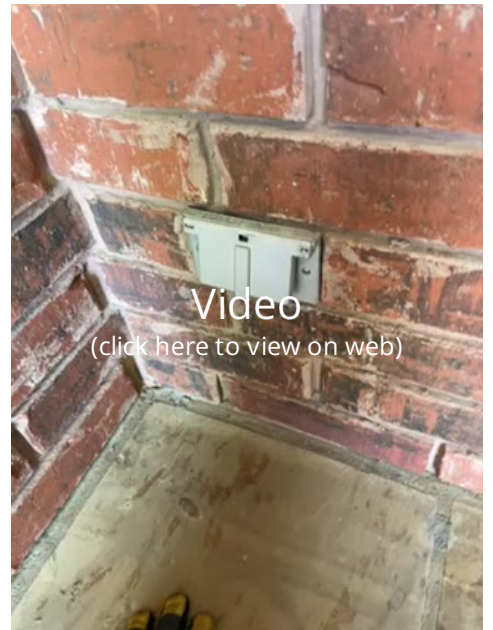
4.7.2 Electrical

COVER LOOSE

Cover is loose, should be tight.

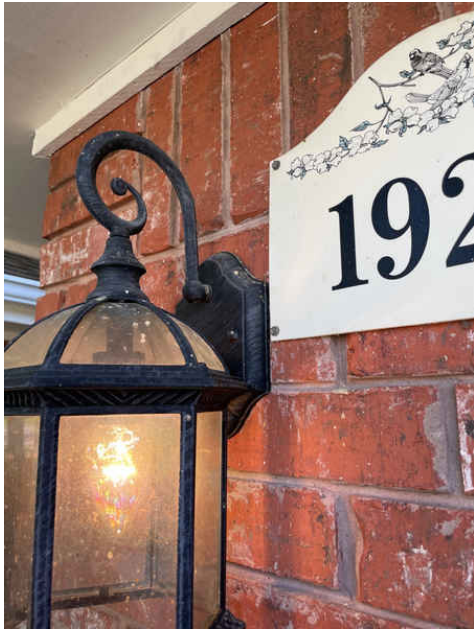
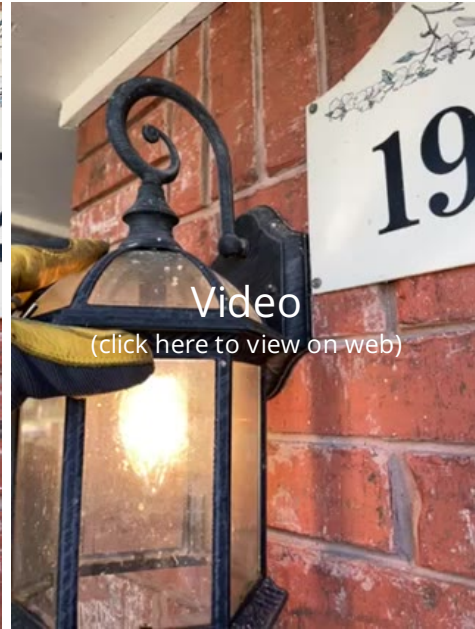
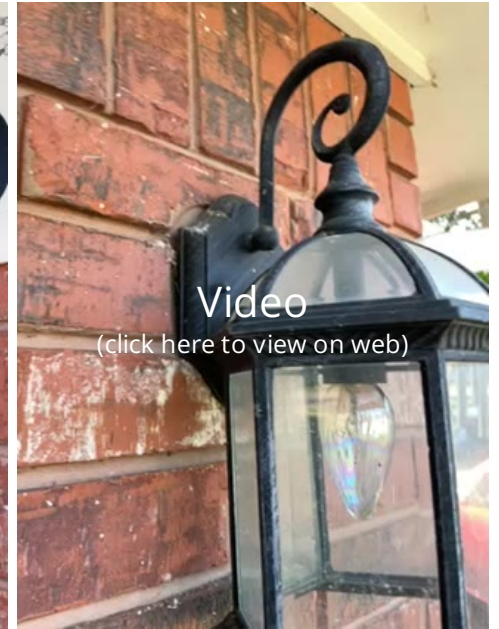
4.7.3 Electrical

LIGHT FIXTURE IS LOOSE

Light fixture is loose, this should be tightened to prevent water intrusion.

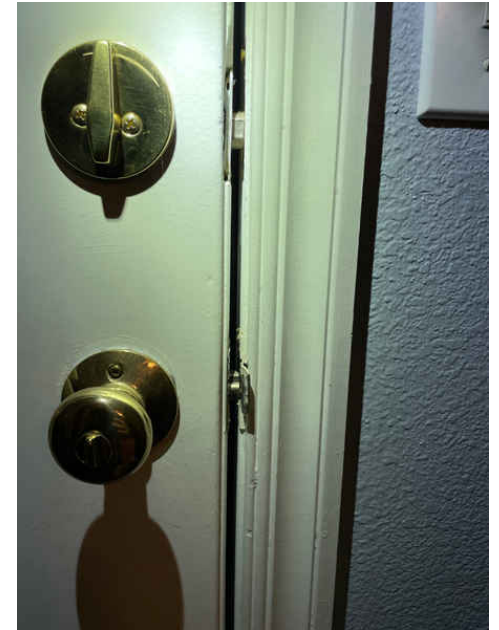
4.8.1 Doors

Door does not close or latch properly. Recommend qualified handyman adjust strike plate and/or lock.

Contact a qualified door repair/installation contractor.

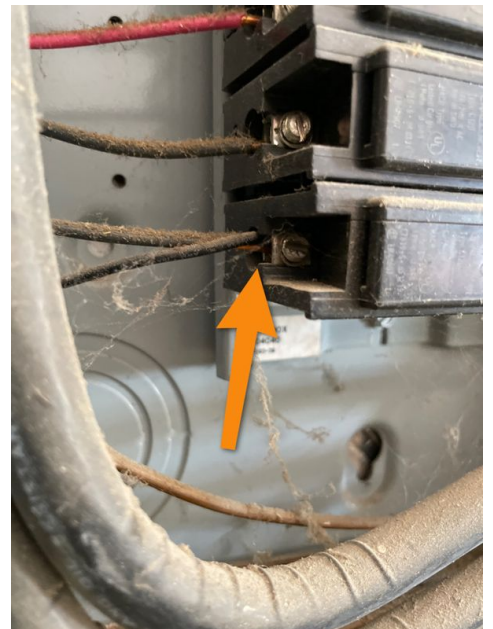
8.4.2 Panelboards & Breakers

DOUBLE TAPPED BREAKERS

Recommendation
Contact a qualified electrical contractor.
