ITEMS INSPECTED

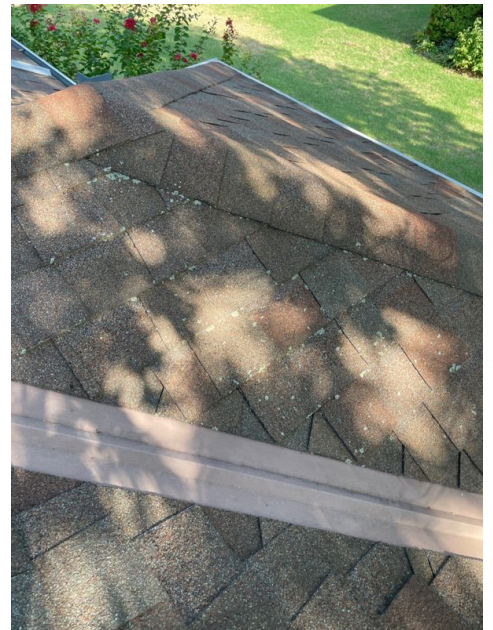
2.1.1 Roof Covering

ASPHALT SHINGLES ARE MOSSY

Mossy shingles are common to north-facing roof slopes and sections overhung by trees. The best fix is prevention: Cutting back branches and periodically clearing debris off the roof will help.

Recommendation
Recommended DIY Project

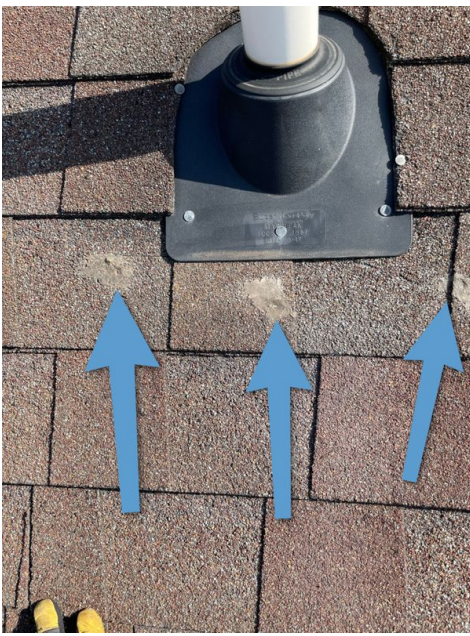
2.1.2 Roof Covering

ROOFING CEMENT PATCHES

Just an FYI, patching usually suggests a homeowner who has found leaks and is trying to buy a few more years by patching obvious cracks and nail pops.

Recommendation
Recommended DIY Project

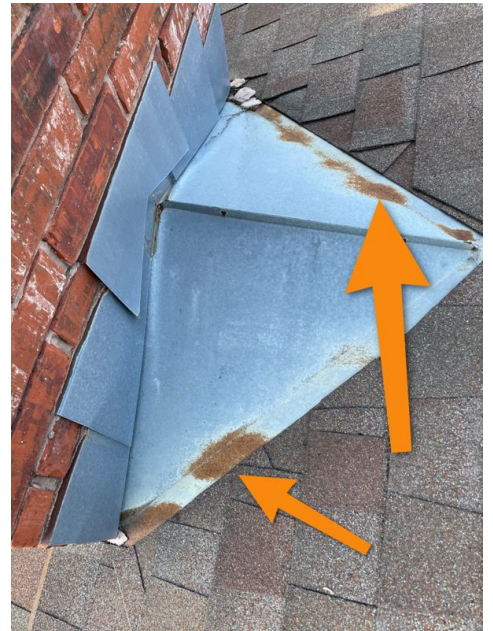
2.2.1 Flashing **CORRODED - MINOR**

Roof flashing showed signs of corrosion, but seemed to not be a major defect. Flashing should be monitored to prevent severe corrosion leading to moisture intrusion.

Recommendation
Contact a qualified roofing professional.

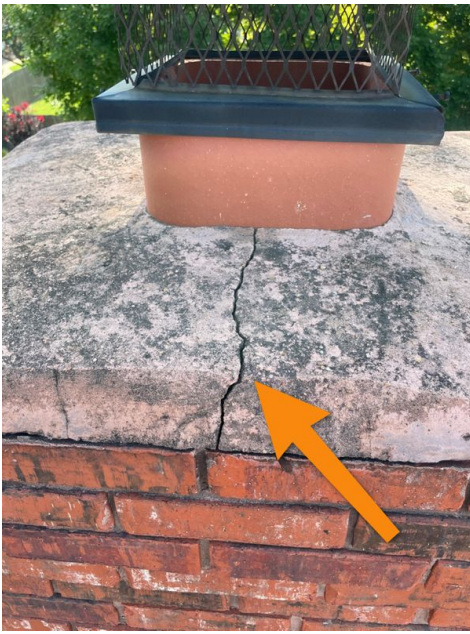
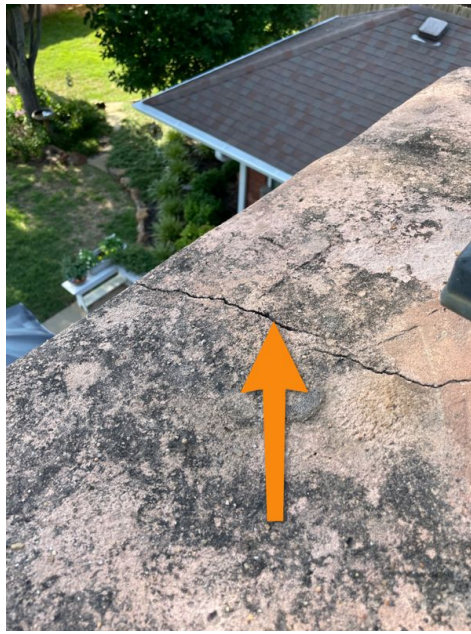
3.1.1 Masonry Chimney **CROWNED CAP WAS DAMAGED**

I observed indications of damage at the chimney wash or crowned cap. This is the top of the chimney that is shaped or "crowned" to divert water away from the top of the chimney stack.

If a wash or crown on top of the chimney is not properly sloped or is extensively cracked, defective, spalled, or displays rust stains, it should be replaced. Sheet metal caps/crowns with minor rust or corrosion should be repaired, but if rust or corrosion is extensive, replacement is recommended.

Recommendation
Contact a qualified chimney contractor.

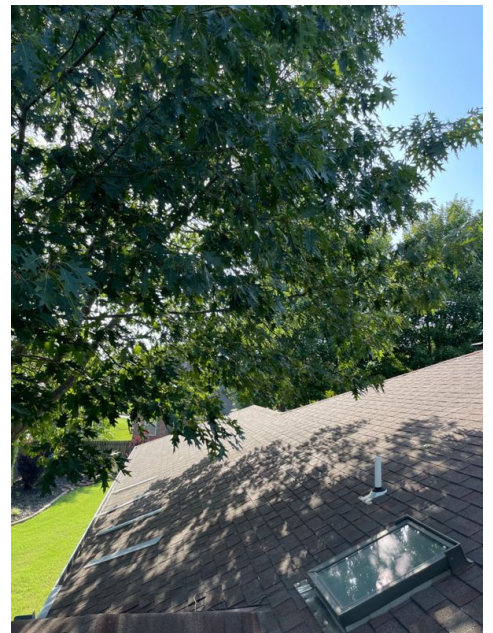
4.4.1 Vegetation, Surface Drainage & Retaining Walls

TREE OVERHANG

Trees observed overhanging the roof. This can cause damage to the roof and prevent proper drainage. Recommend a qualified tree service trim the limbs back.

Contact a qualified tree service company.

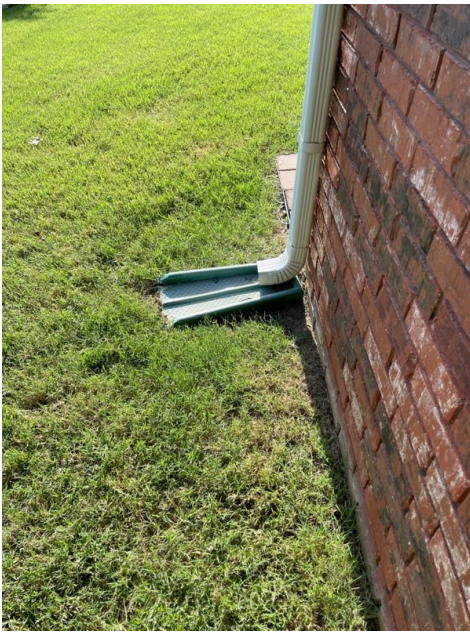
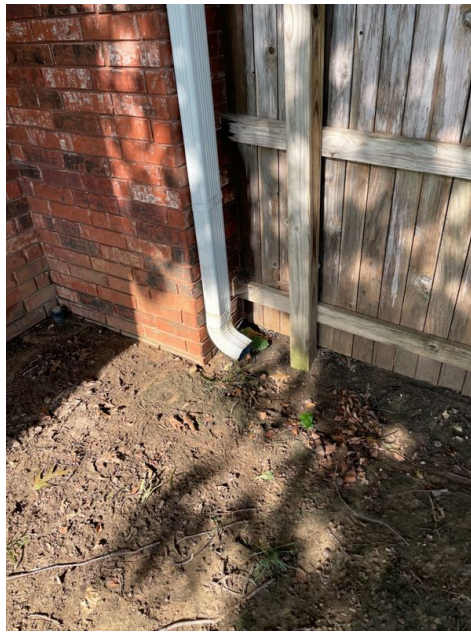
4.5.1 Gutters & Downspouts

DOWNSPOUT DRAINS NEAR HOUSE

One or more downspouts drain too close to the home's foundation. This can result in excessive moisture in the soil at the foundation, which can lead to foundation/structural movement. Recommend a qualified contractor adjust downspout extensions to drain at least 6 feet from the foundation. A handy homeowner should be able to do this project.

Recommended DIY Project

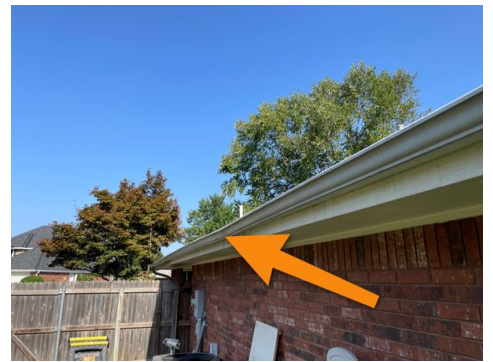
4.5.2 Gutters & Downspouts

GUTTER DAMAGED

I observed damage to the gutter. This is a defect that should be corrected by a professional contractor.

Contact a qualified gutter contractor

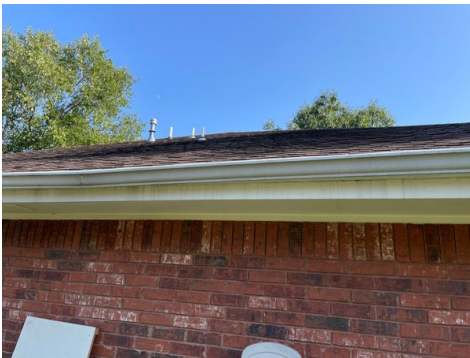
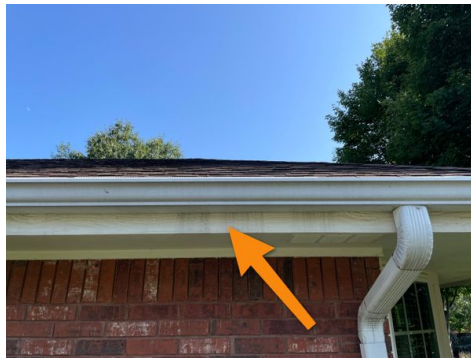
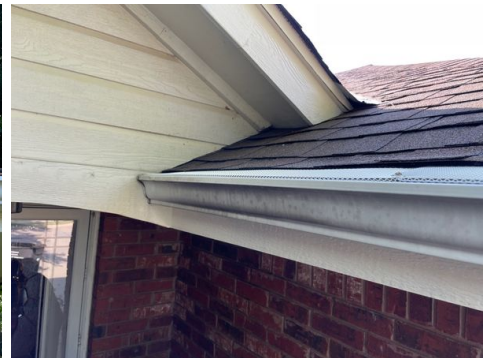
4.5.3 Gutters & Downspouts

GUTTER LEAKAGE

I observed evidence of a water leak from a gutter, which could result in water not being properly collected and drained away. This is a defect that should be corrected by a professional contractor.

Contact a qualified gutter contractor

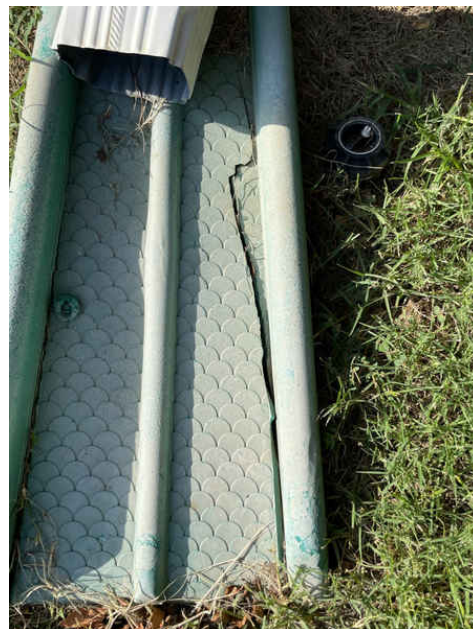
4.5.4 Gutters & Downspouts

DIVERTER BROKEN OR CRACKED

Diverted is cracked or broken, this can allow water too close to the foundation.

Recommendation
Contact a qualified professional.

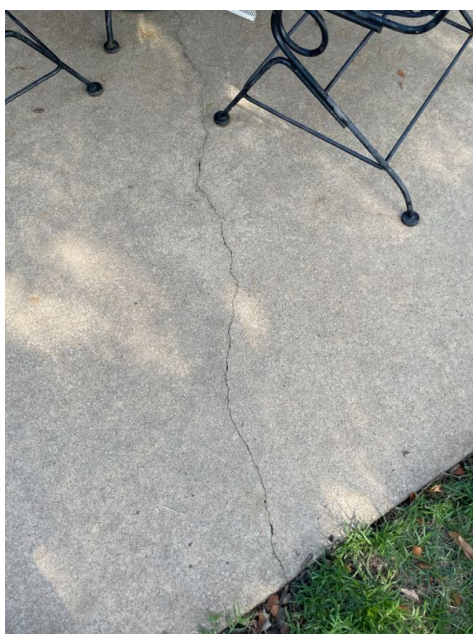
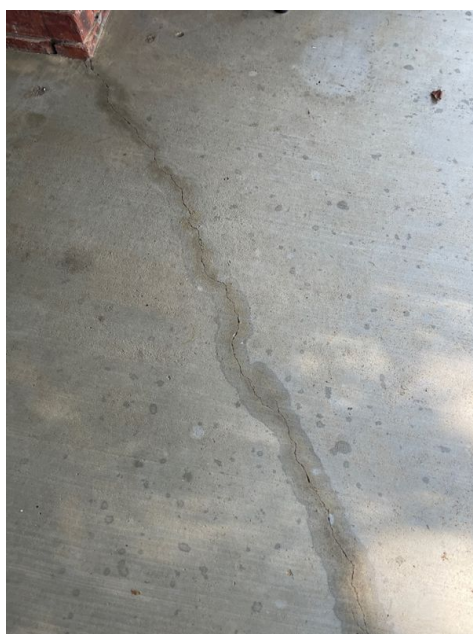
4.6.1 Decks, Patios & Balconies

PATIO CRACKING - MINOR

Normal settling & cracking observed. Recommend monitor and/or patch/seal.

Recommendation
Contact a handyman or DIY project

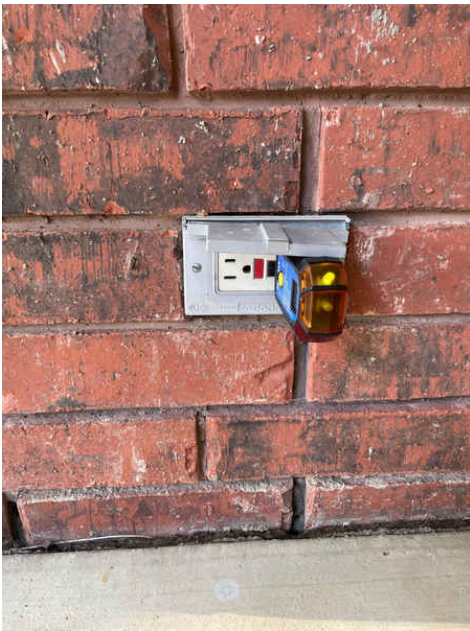
4.7.1 Electrical

GFCI DEFECT

I observed indications of a defect at a GFCI. Would not trip.

Recommendation
Contact a qualified electrical contractor.

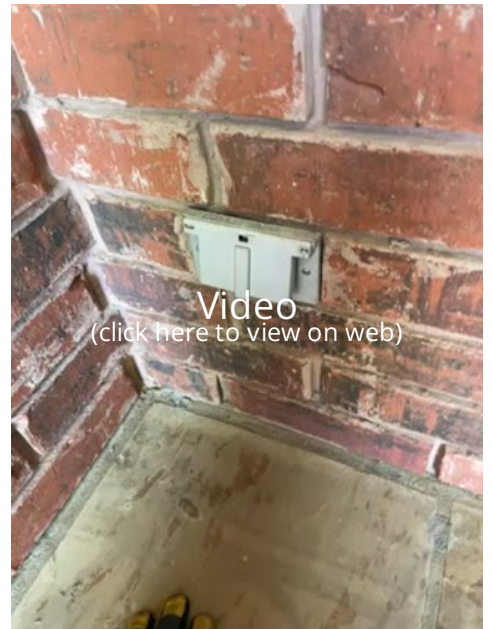
4.7.2 Electrical **COVER LOOSE**

Cover is loose, should be tight.

Recommendation
Contact a qualified professional.

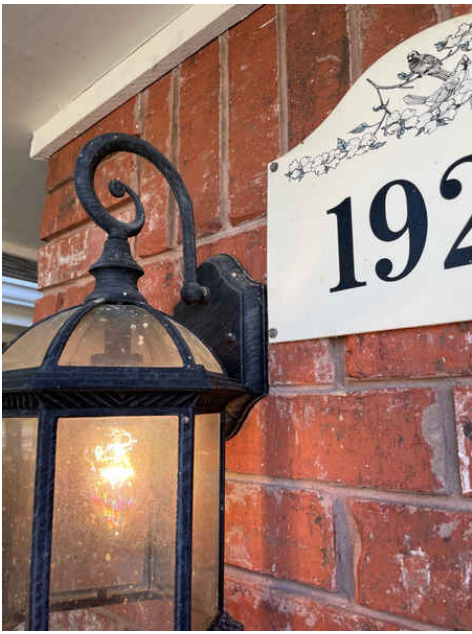
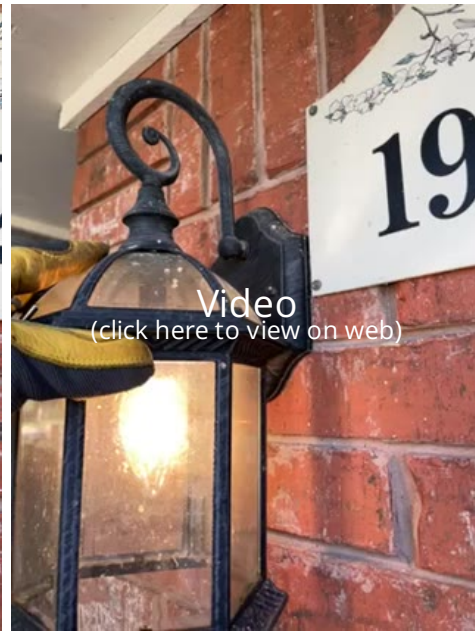
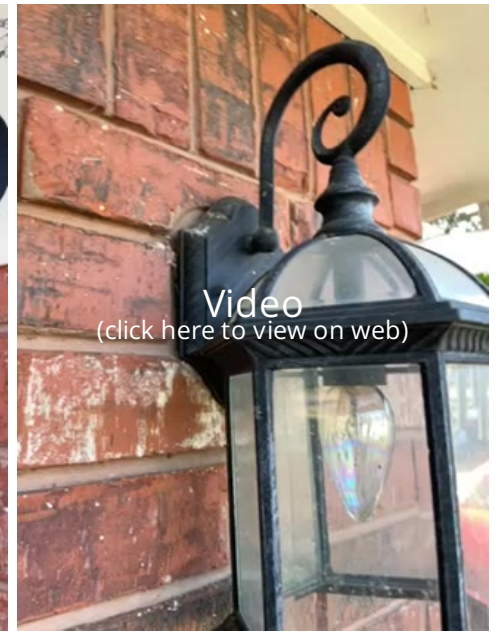
4.7.3 Electrical **LIGHT FIXTURE IS LOOSE**

Light fixture is loose, this should be tightened to prevent water intrusion.

Recommendation
Contact a qualified professional.

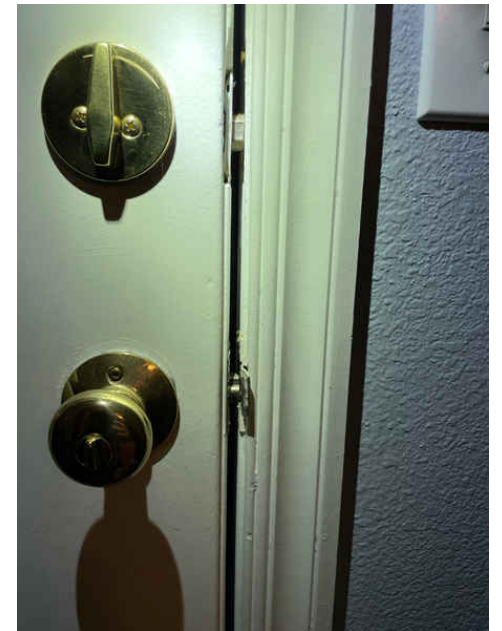
4.8.1 Doors

DOOR DOES NOT CLOSE OR LATCH

Door does not close or latch properly. Recommend qualified handyman adjust strike plate and/or lock.

Contact a qualified door repair/installation contractor.

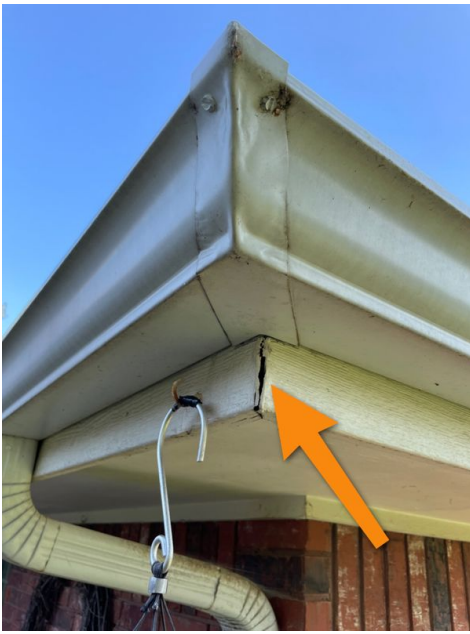
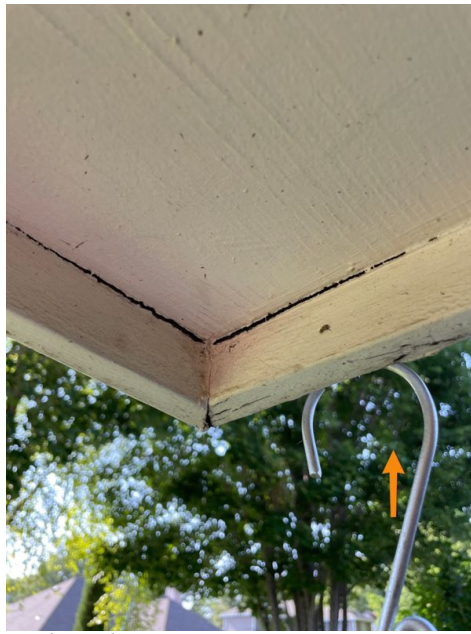
4.11.1 Eaves, Soffits & Fascia

FASCIA DAMAGED

I observed indications that one or more areas of the fascia were damaged.

Correction and further evaluation is recommended.

Contact a qualified roofing professional.

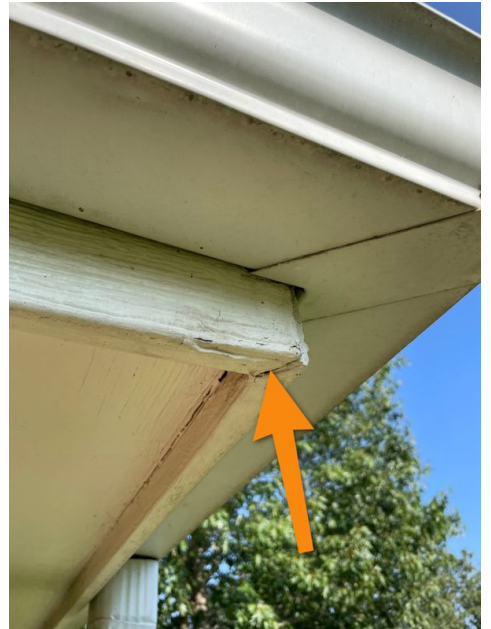
4.11.2 Eaves, Soffits & Fascia

FASCIA ROTTED

One or more sections of the fascia are rotted. Recommend qualified roofer evaluate & repair.

Contact a qualified roofing professional.

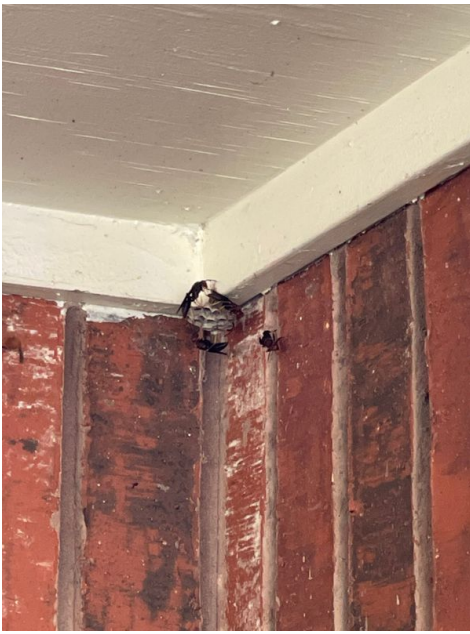
4.11.3 Eaves, Soffits & Fascia

WASPS NEST

Wasp nests were visible under the soffits. Recommend a qualified exterminator evaluate and remove.

Contact a qualified pest control specialist.

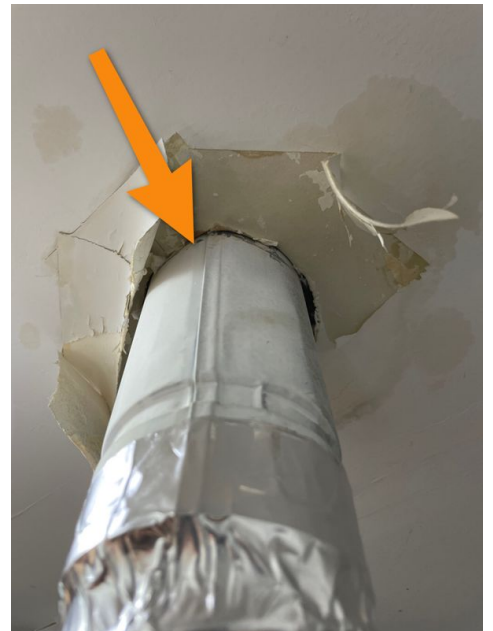
5.4.1 Hot Water Source (Heater)

DOUBLE-WALL FLUE PIPE NEEDS 1 IN. CLEARANCE

There should be at least 1 in. between double-wall metal flue pipe and combustible surfaces such as wall or floor framing.

Contact a qualified HVAC professional.

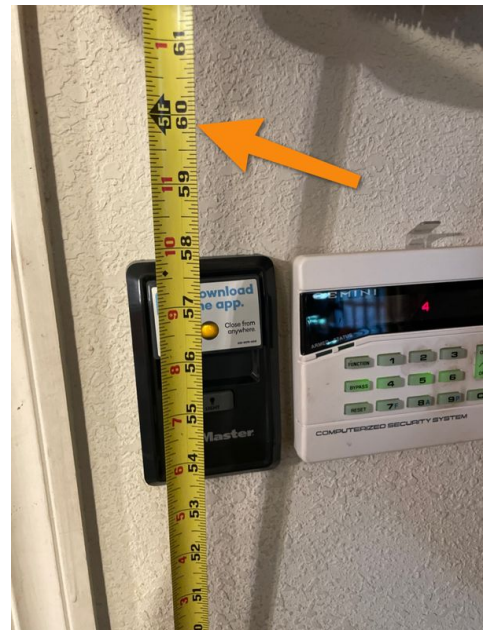
7.3.2 Garage Door Opener

WALL BUTTON LESS THAN 5 FT. OFF FLOOR

The wall button should be at least 5 feet above the standing surface, and high enough to be out of reach of small children.

Recommendation
Contact a qualified garage door contractor.

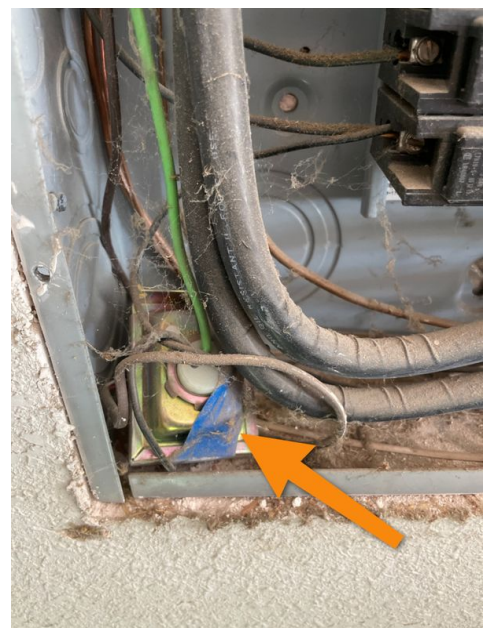
8.4.1 Panelboards & Breakers

DOORBELL TRANSFORMER INSIDE CABINET

I observed that the doorbell transformer was installed within the cabinet, which is not permitted.

Recommendation
Contact a qualified electrical contractor.

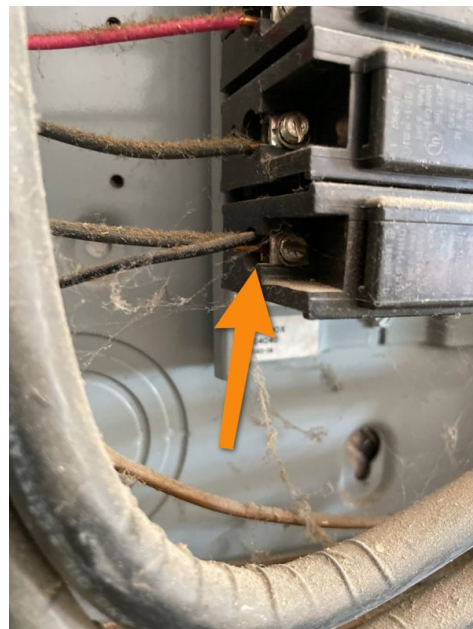
8.4.2 Panelboards & Breakers

DOUBLE TAPPED BREAKERS

I observed doubled hot conductor wires connected to the same single breaker disconnect.

Each breaker should have just one conductor wire connected to it.

Recommendation
Contact a qualified electrical contractor.

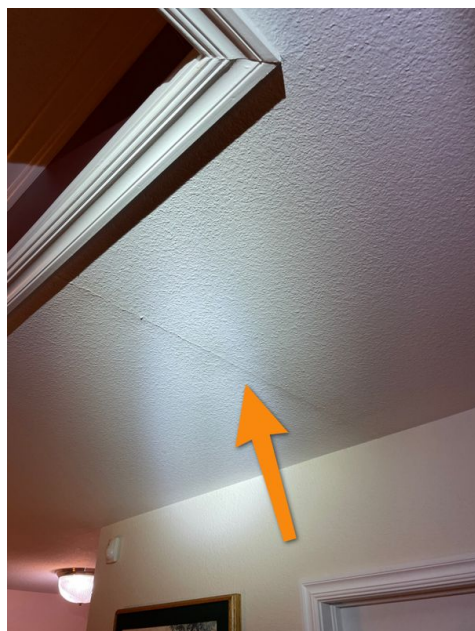
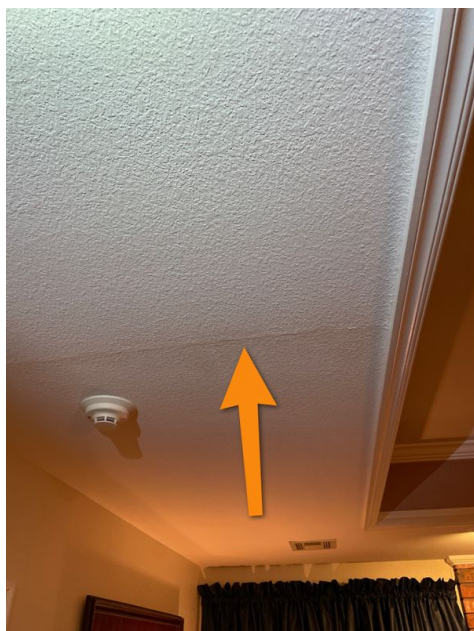
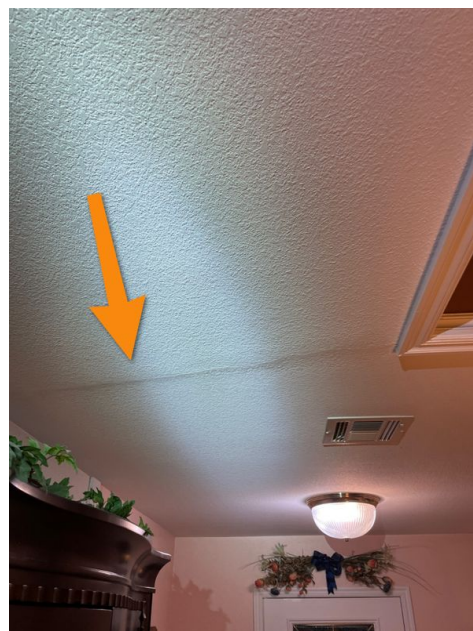
9.3.1 Floors, Walls & Ceilings CEILING, MINOR DAMAGE

Minor damage or deterioration to the ceiling was visible at the time of the inspection.

Recommendation
Contact a qualified professional.
